Manhole Inspection Summary

Manhole # S23GG_009MH

Location Address: **1526 CAREY ST** Cross Street: **PRESSTMAN ST**

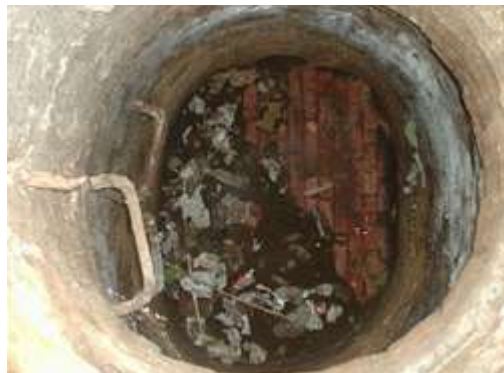
Top View

Channel Material: **Brick** ☐ Parged ☒ **Debris** (not Condition related)
Channel Exposure: **Fully Open** Junc Dist: **0** nearest .5 ft. Azimuth:
Condition: ☒ Sound ☐ Cracked ☐ Root Intrusion ☐ Deteriorated ☐ Leaks ☐ Debris

Steps Count: **4** Missing: **1** ☒ **Corroded**

Corroded and missing steps. Channel debris.

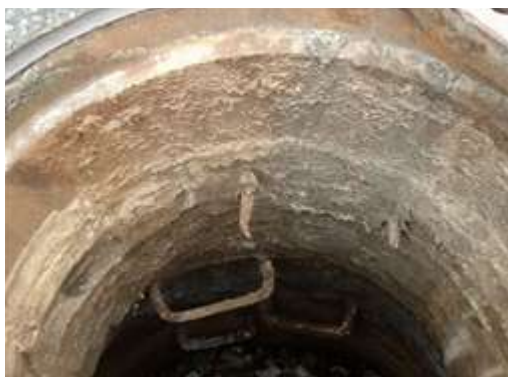
Defect

Frame Offset: **0** (in.) Condition: ☐ Sound ☐ Cracked ☒ **Leaks**

Chimney / Frame Adjustment ☒ Exists Material: **Brick** ☐ Parged Height: **9** (in.)
Condition: ☐ Sound ☐ Cracked ☐ Root Intrusion ☐ Loose Brick ☒ **Deteriorated**
Infiltration: ☐ None ☒ **Joint** ☐ Cracks ☐ Mortar ☐ Roots ☒ **Wall**

Barrel Material: **Brick** ☐ Parged
Shape: **Circular** Diameter: **42** (in.) Length: (in.)
Condition: ☒ Sound ☐ Cracked ☐ Root Intrusion ☐ Loose Brick ☐ Deteriorated
Infiltration: ☐ None ☐ Joint ☐ Cracks ☒ **Mortar** ☐ Roots ☒ **Wall**

Frame leaks. Adjustment deterioration and infiltration. Barrel infiltration - other side.

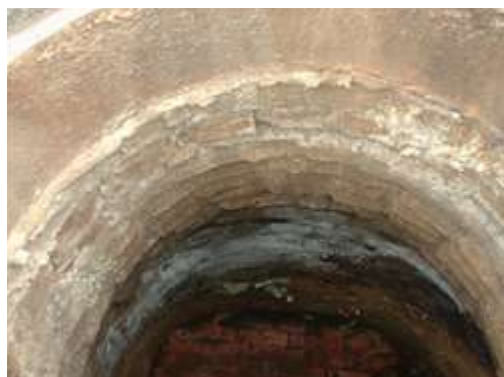
Defect

Frame leaks. Adjustment deterioration and infiltration. Barrel infiltration.

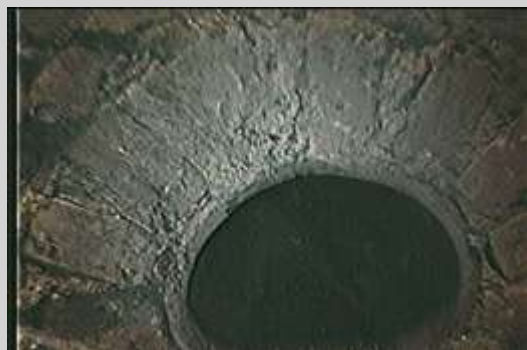
Pipe Out @ 12 O'Clock

Pipe Seal Cond: **Cracked**
